2024 GAS LIFT WORKSHOP

Erosion Testing of Gas Lift Check Valves for Unconventional Applications

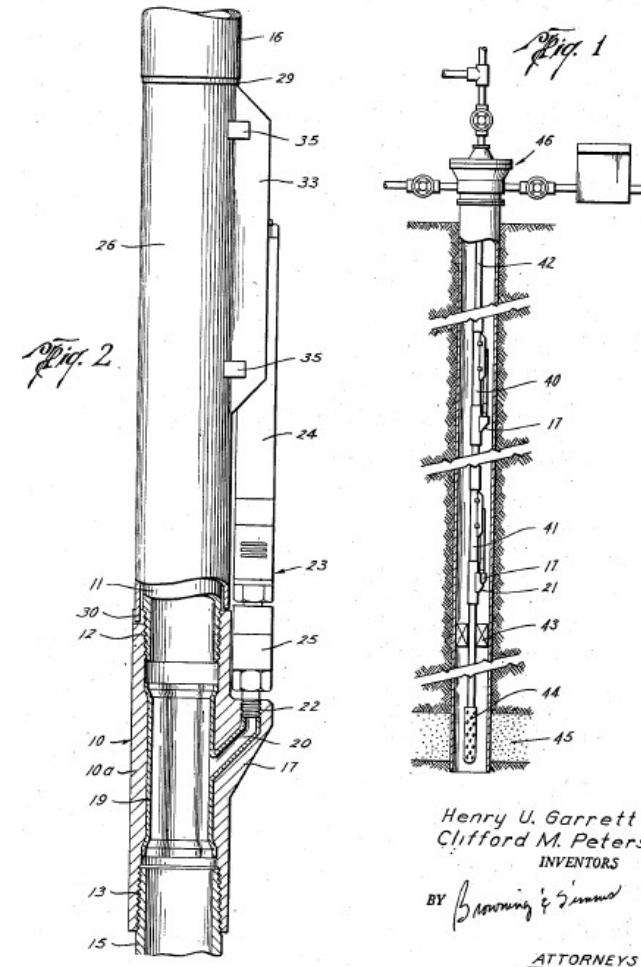
2,845,940

H. U. GARRETT ET AL
GAS LIFT MANDREL AND VALVE

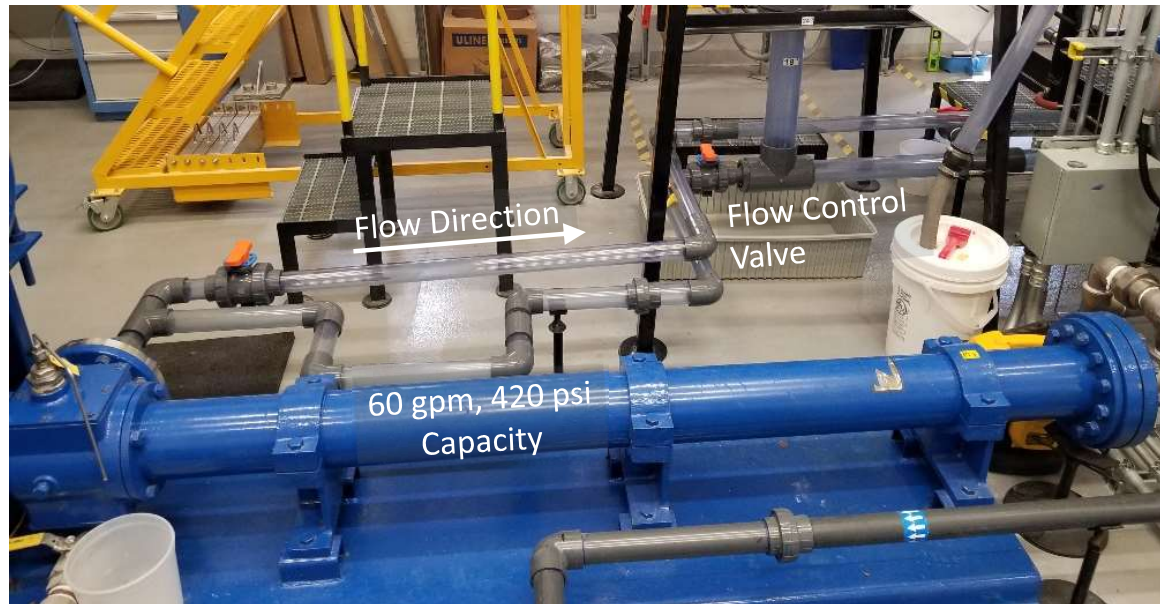
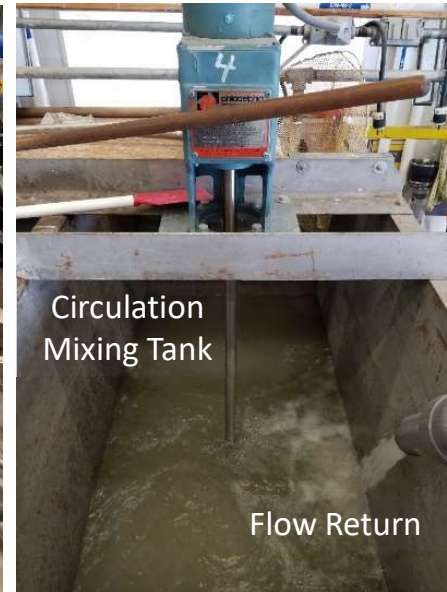
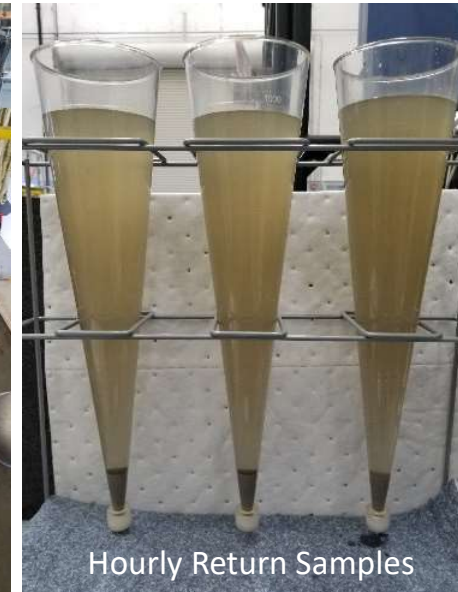
- Goal is 1% (by weight) sand erosion testing at 1 bbl/min for 400 bbl
- Attempted 0.5 bbl/min for “easier” test, but found that sand dropped out of solution
- Minimum injection rate for suspension is 0.6 bbl/min
- 70/100 mesh sand replaced every few runs to ensure angularity

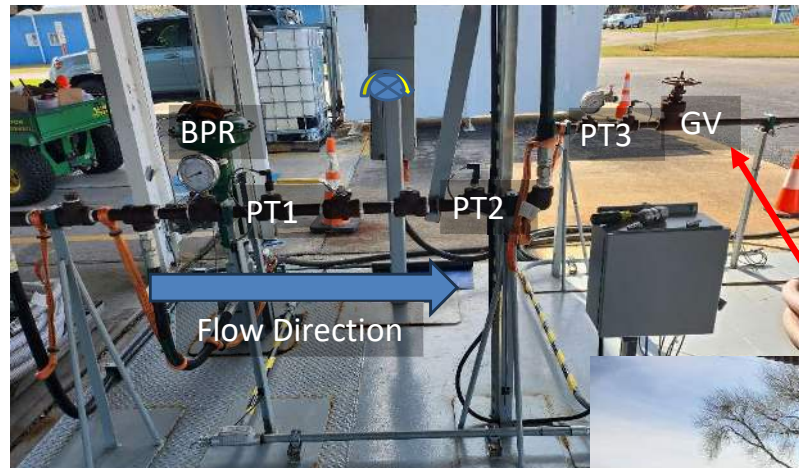
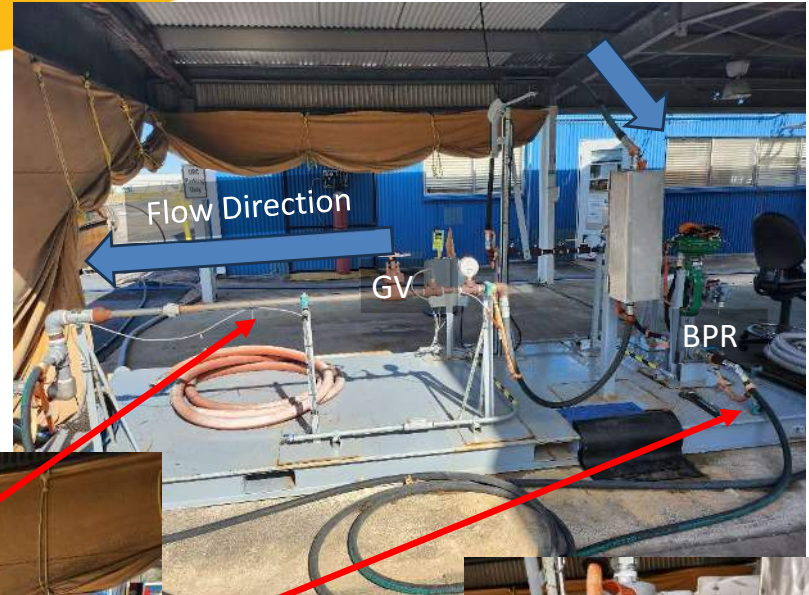
Flow Loop

Front

GLV Test Skid

Back

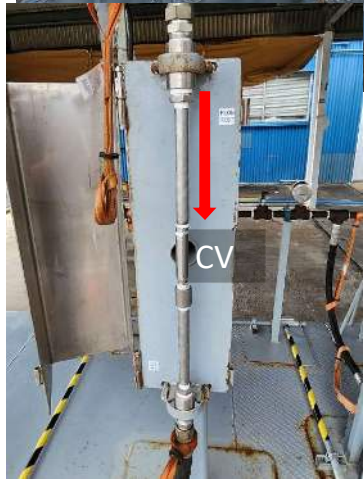
Flow Test
Flow Into
Dart Tip

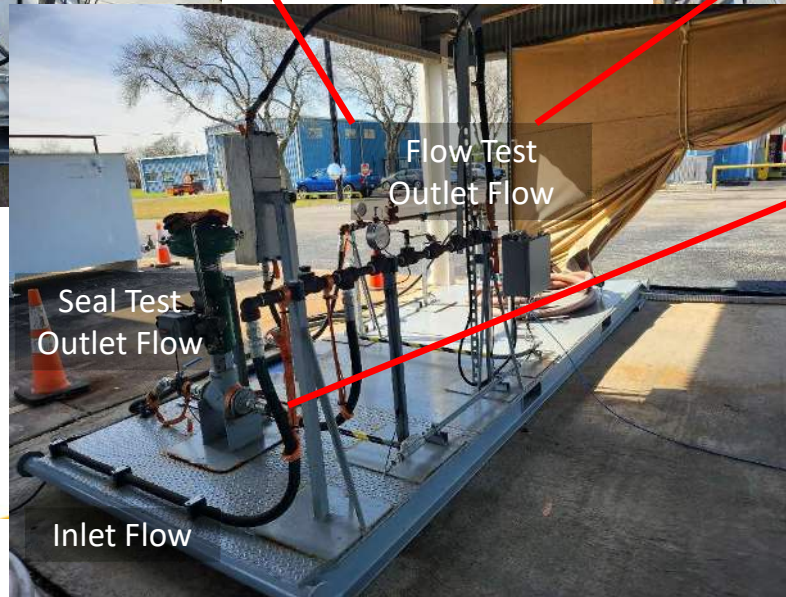
Seal Test
Outlet Flow

Inlet Flow

Flow Test
Outlet Flow

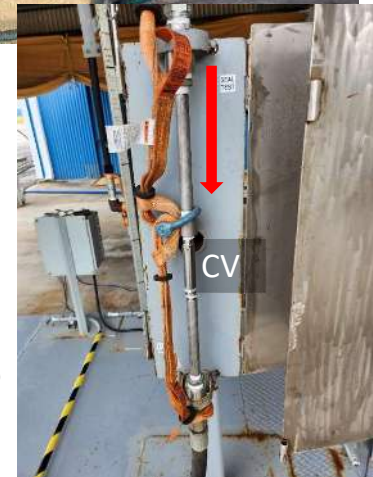
Seal Test
Flow Into
Spring

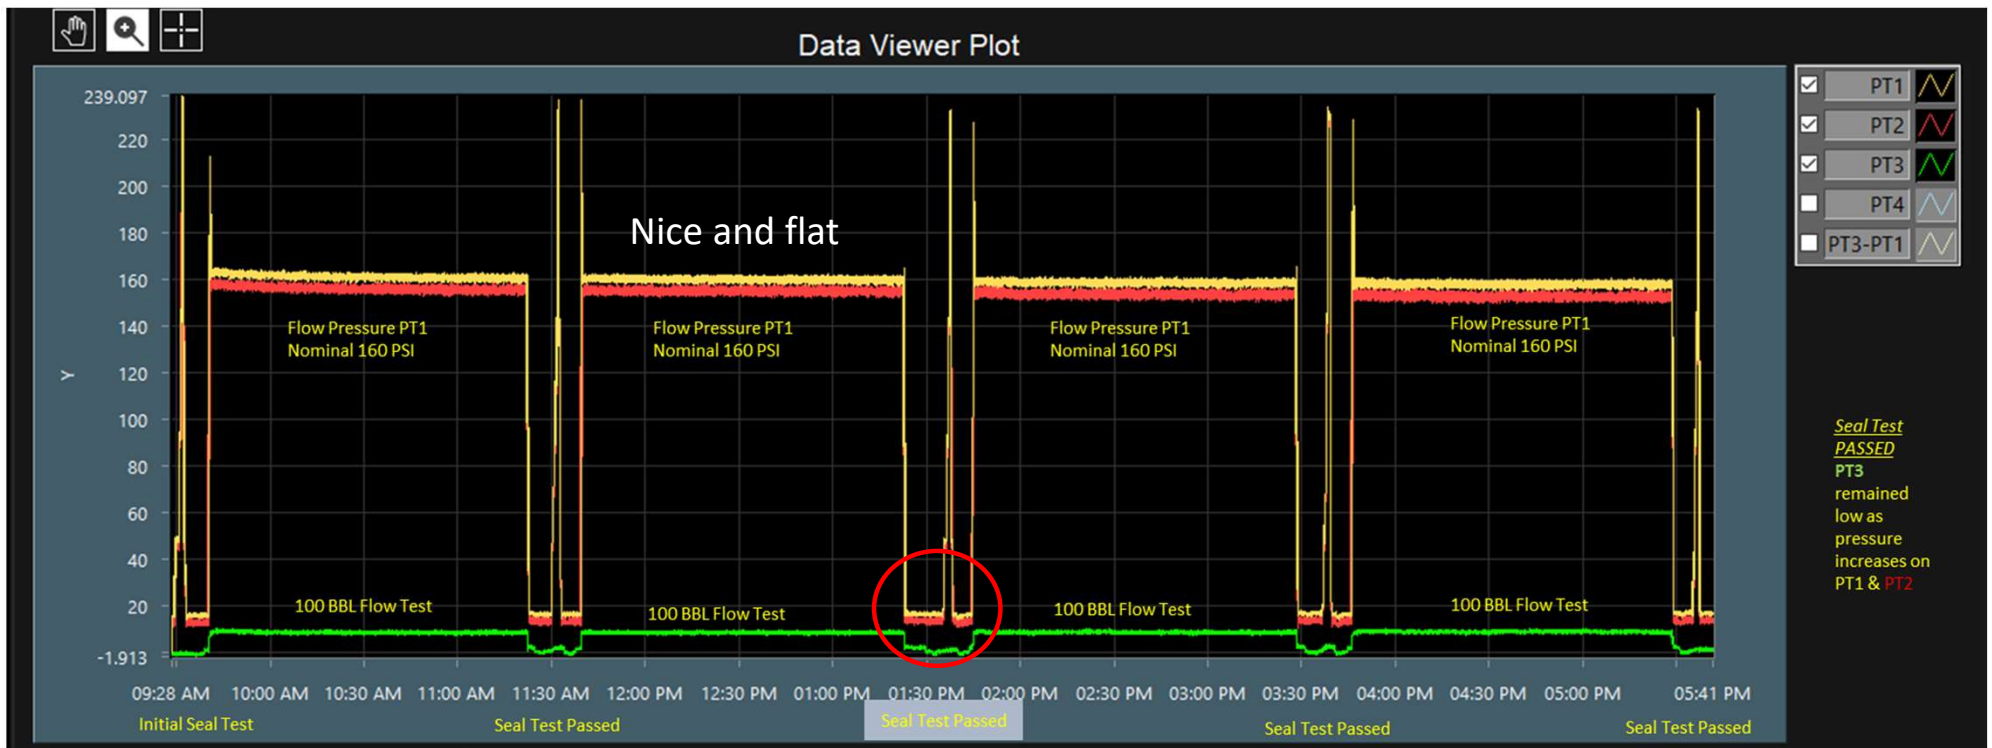
Model B.A

What “good” looks like...

PT2 and PT3 do not equalize during the seal test

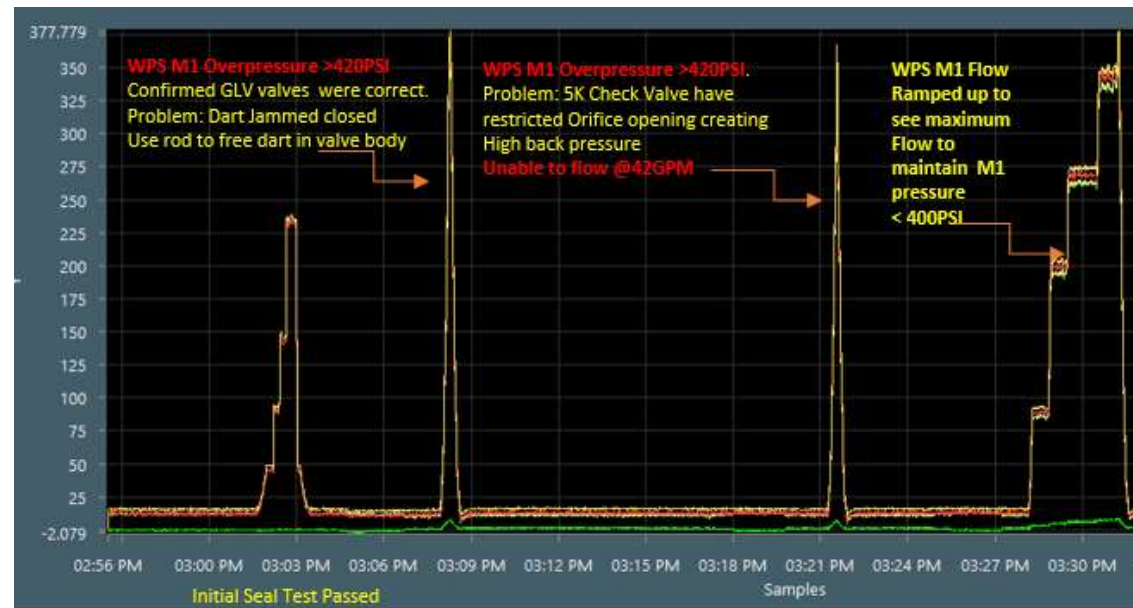
Model C.A

Other failure had a “unique” sealing design, improvements identified

5K(psi) check dart jammed in the body and had to be punched out, some had missing/broken springs. All others tested were 10K

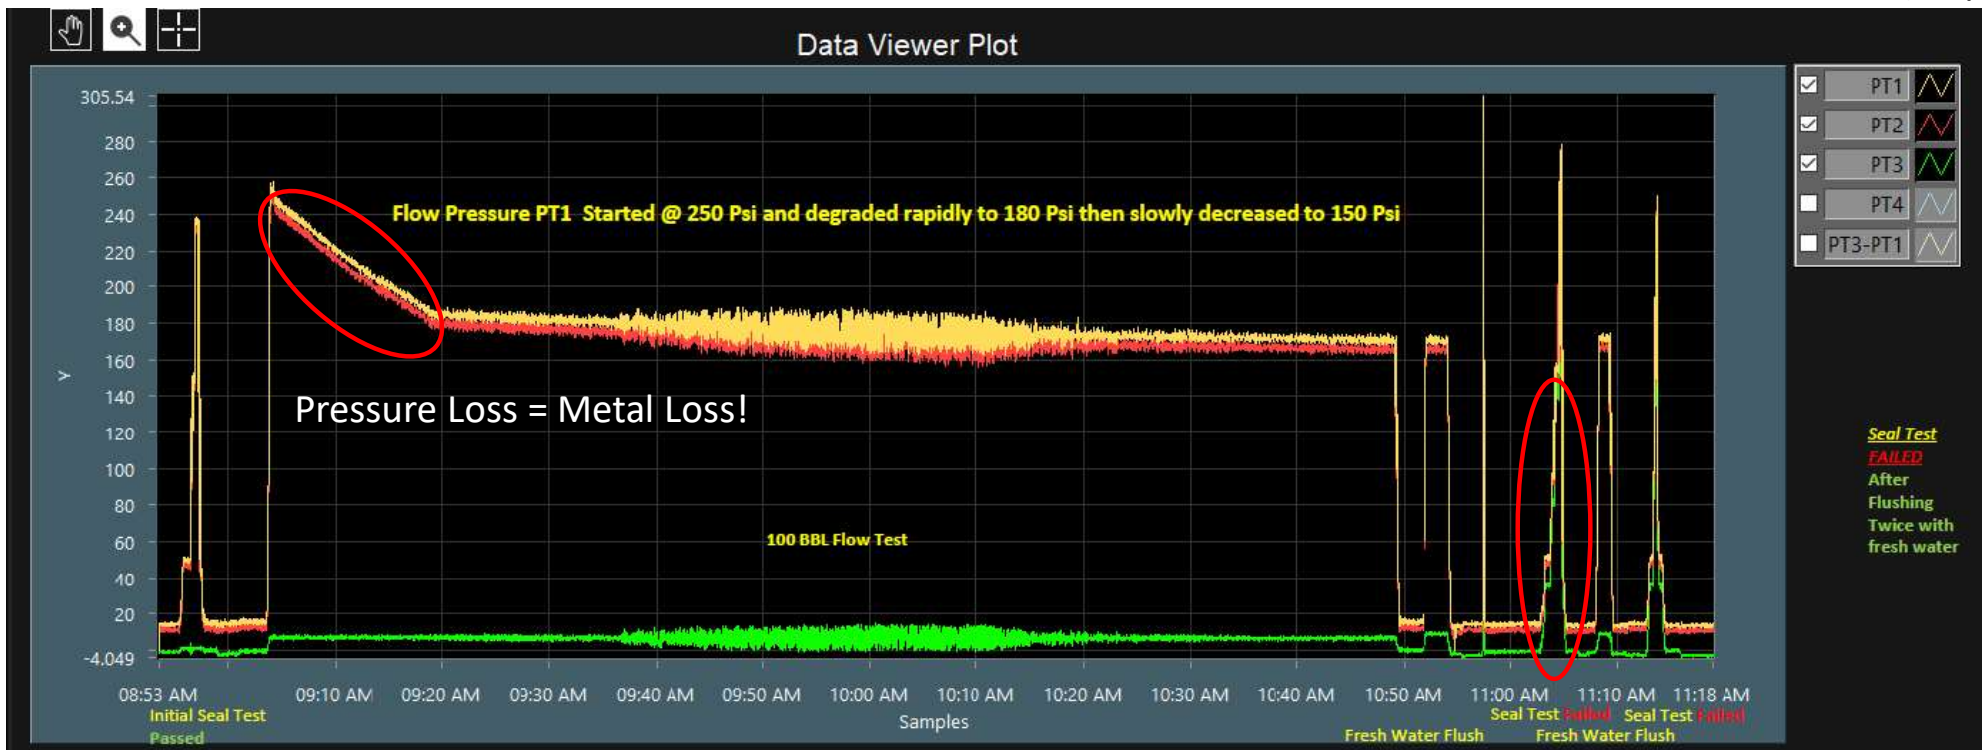
Model E.A

What wear looks like (1 bpm)...

PT2 = PT3 = No Seal

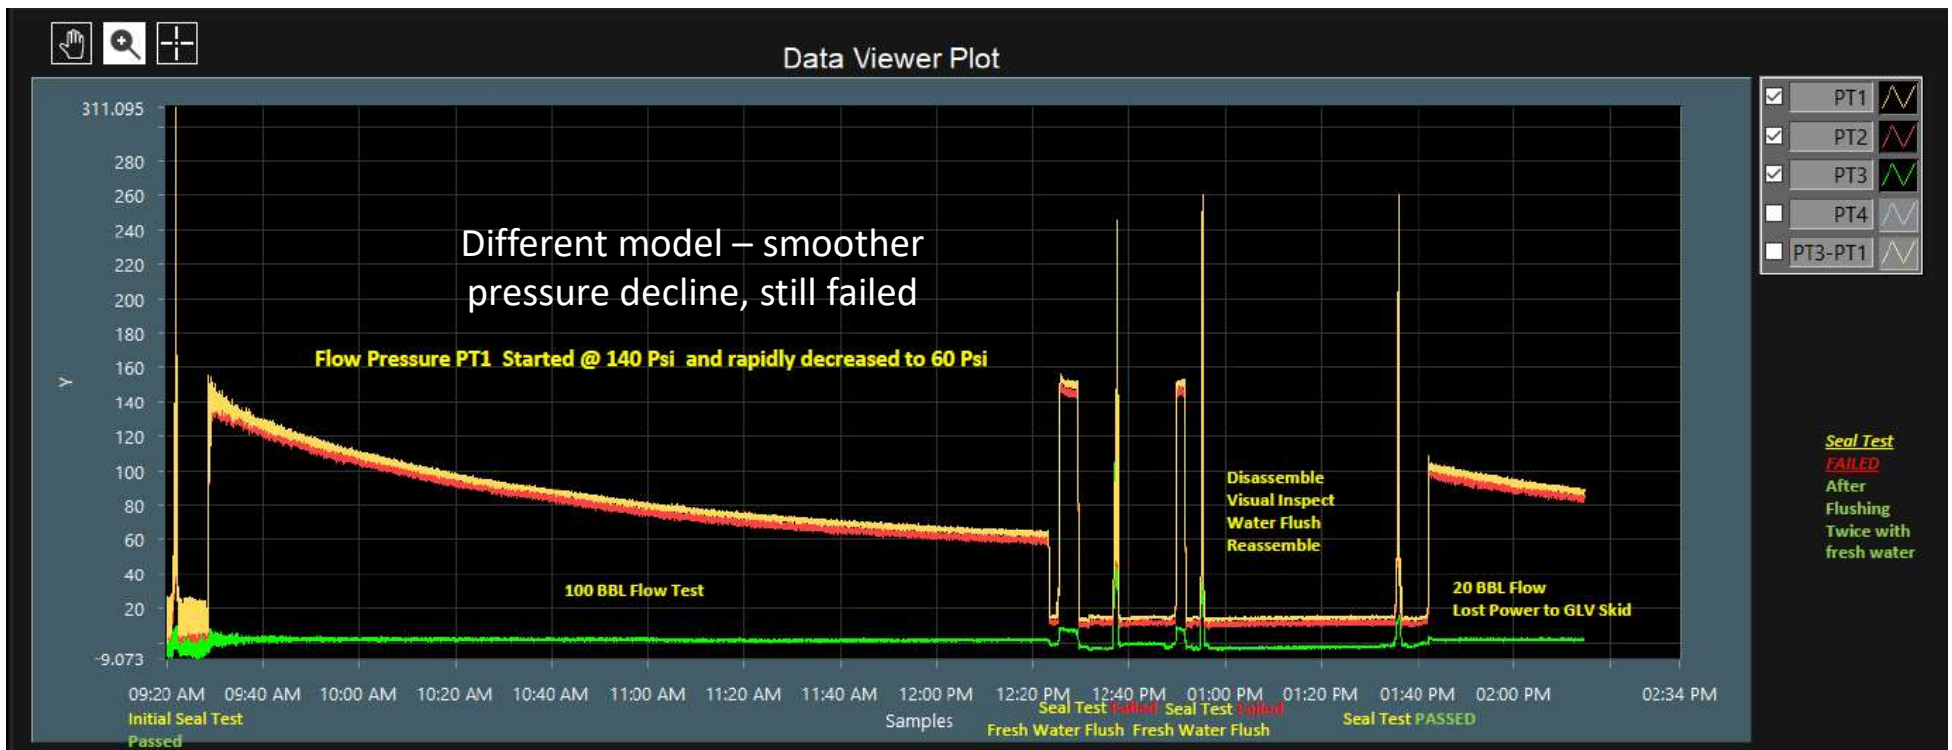
Model B.A

Sand Erosion Results

- No seal after flushing = failure
- Sealing after punching free still = failure
- Failure modes mimicked those seen in equipment pulled from the field
- Dual checks did not solve the problem

- Eroded/cut sealing faces
- Broken/missing springs
- Solids sticking (holding open)
- Bored/fluted flow paths
- Cascading debris

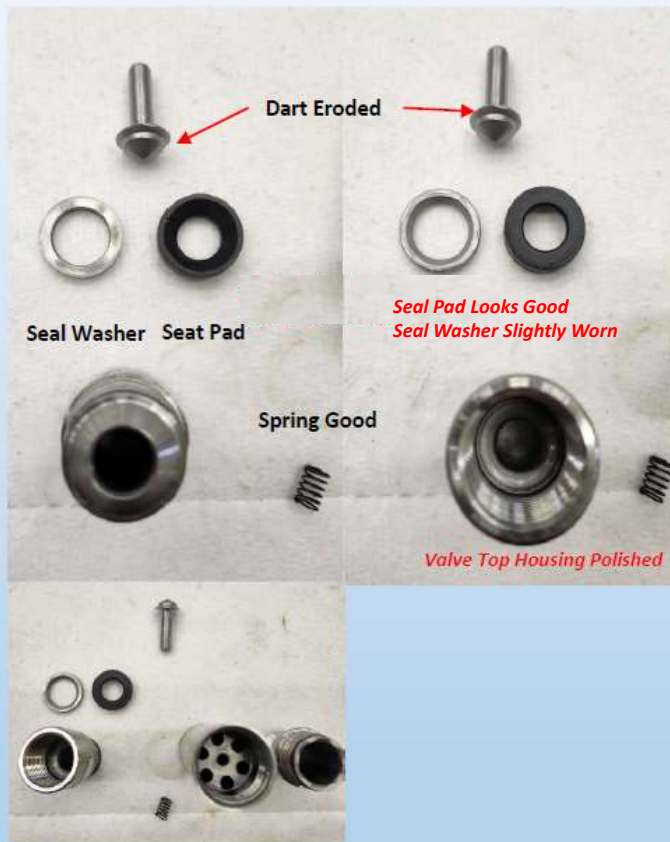
Check Valve Assembly

Note check housing “fluting” in line with the flow ports; results shown at 0.6 bpm unless specified otherwise

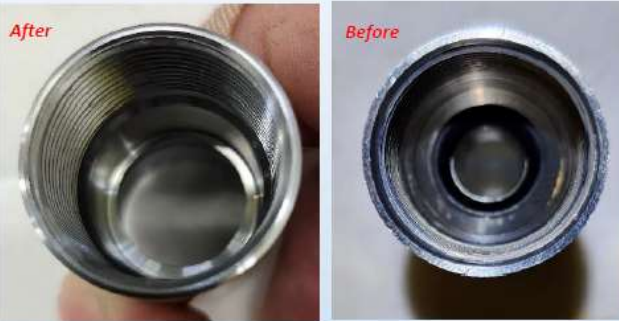
Valve Seal Housing Assembly

Note dart erosion, polishing/wear and “unsticking” punch

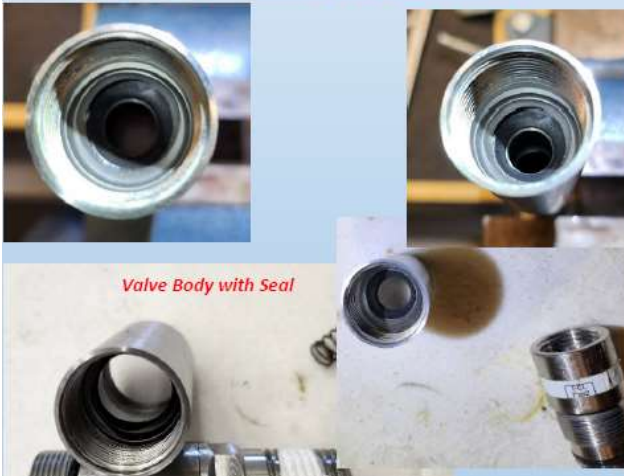
Valve Body without Seal after 200BBL Erosion Test

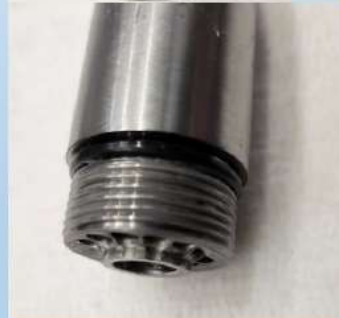
Inlet Top Housing

Polished Opening Eroded ~0.156"

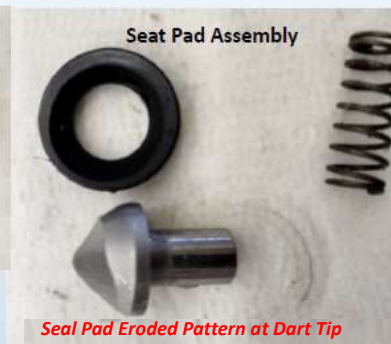
Dart & Seal Assembly

Seal Pad Eroded Pattern at Dart Tip

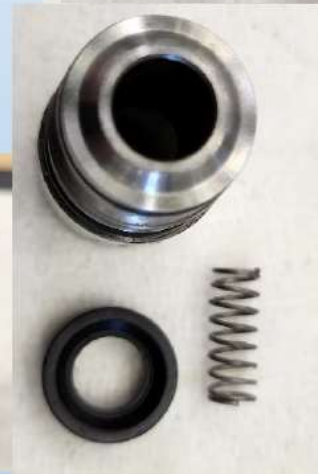
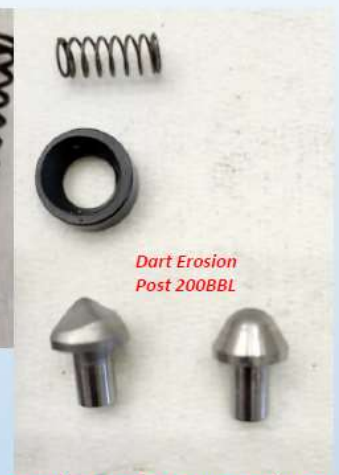
Dart & Seal Assembly

Dart Erosion Post 200BBL

Dart After & Before 200BBL Erosion Test

Punch Set Used to Free the Dart then Flush Assembly Before Seal Integrity Test

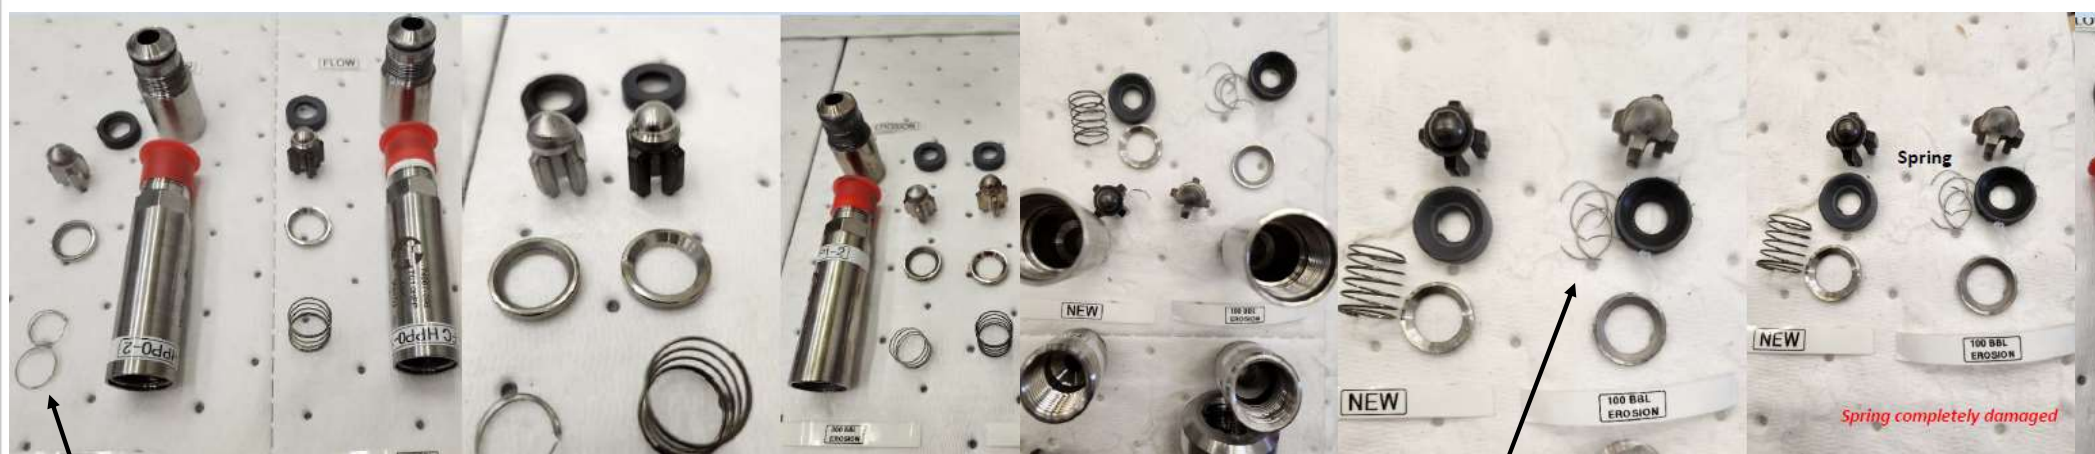
Broken / missing springs
in after/before photos

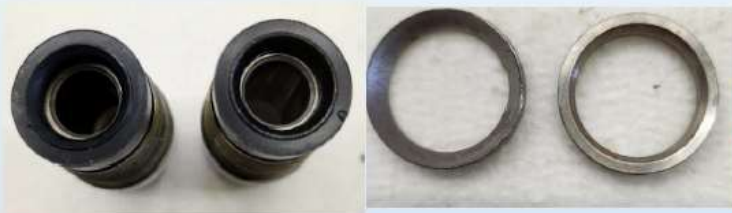
Seal Pad and Washer Worn After 400 BBL

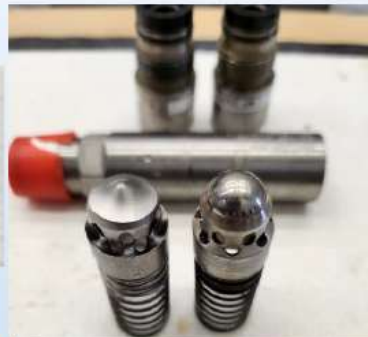
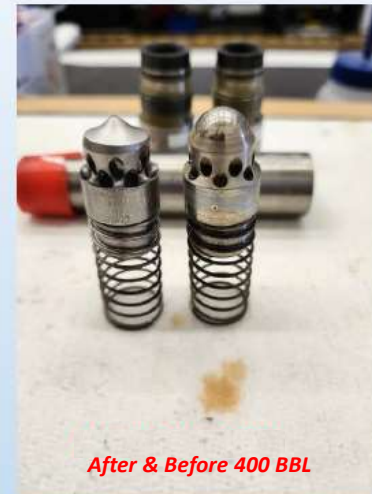
Check Valve Assembly After 400 BBL

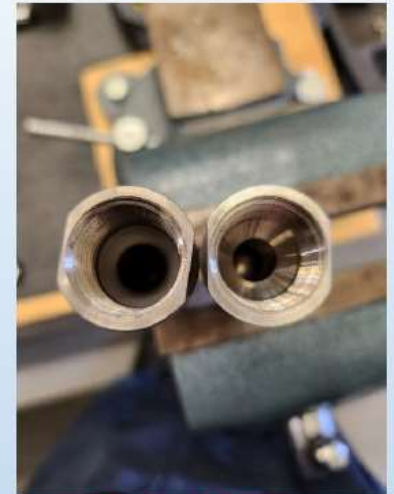
Valve Top Housing Polished

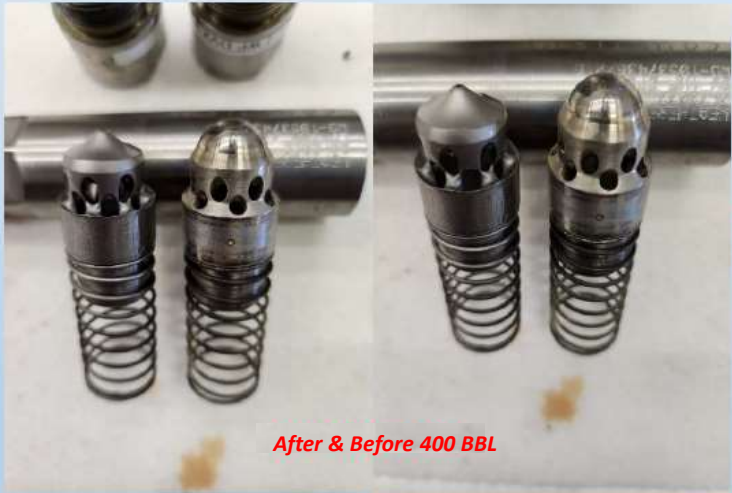
After & Before 400 BBL

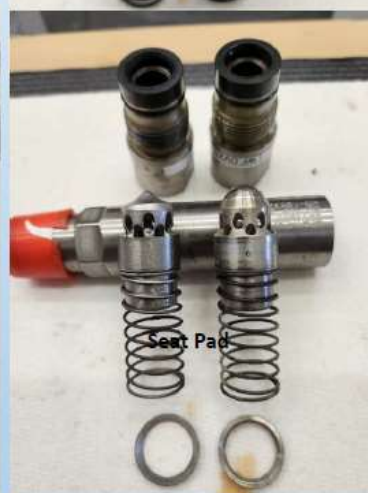
Seal Pad

Note seal face changing from a sphere to a cone

After 400 BBL 1% Sand Erosion

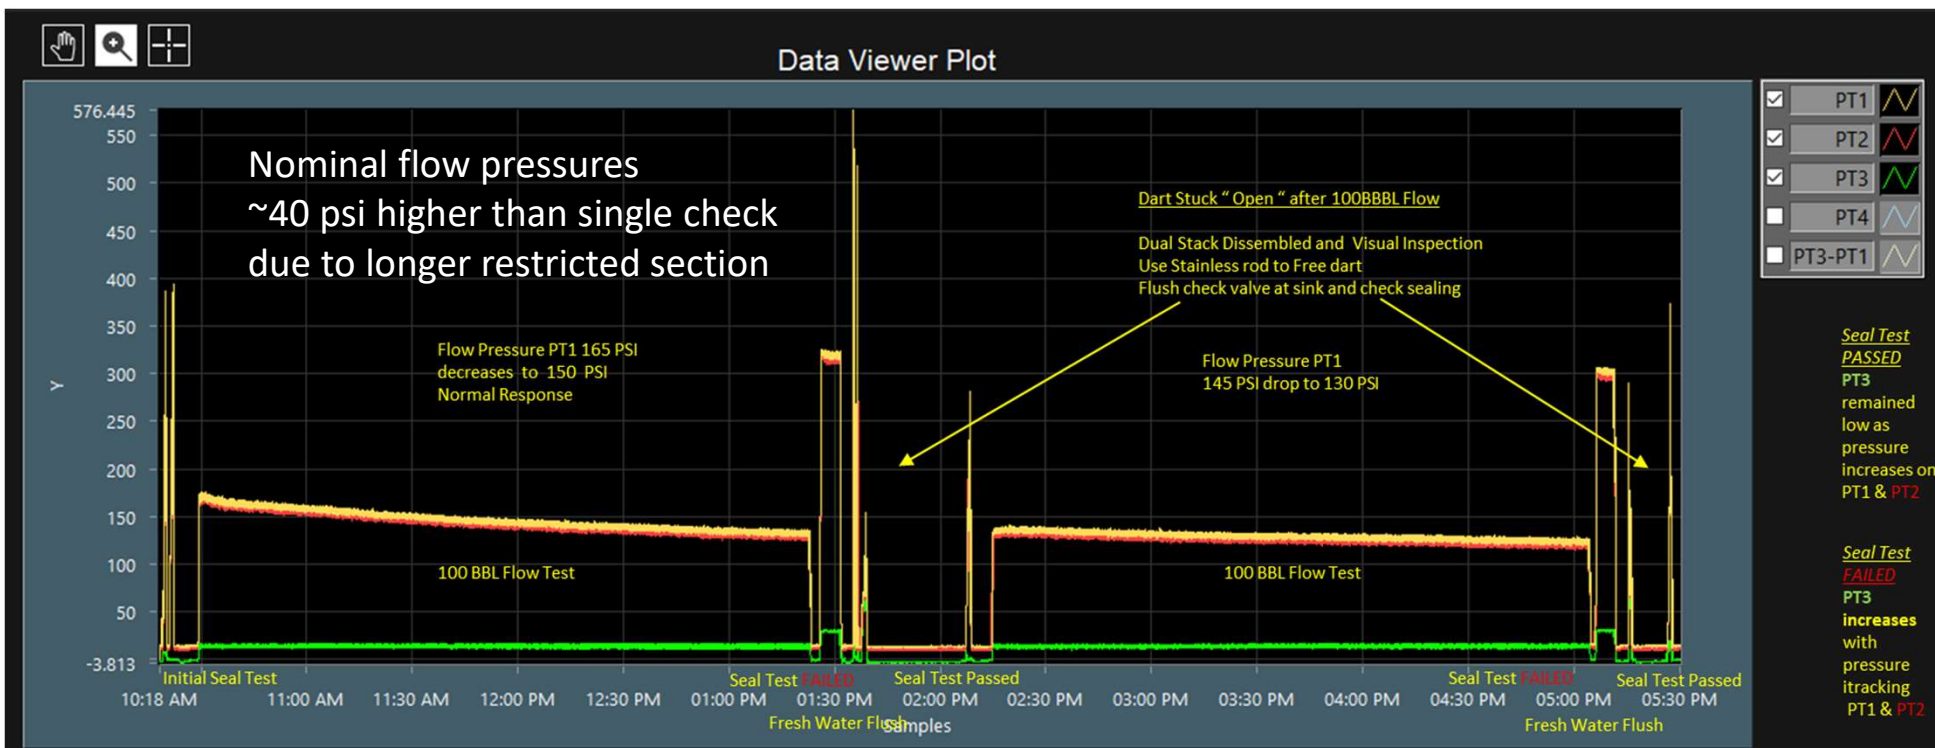
Sand Erosion Results – Dual Checks

If one is good, then two are better, right?

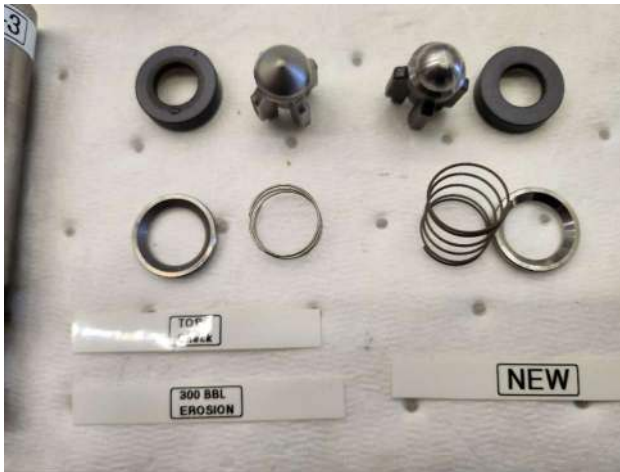
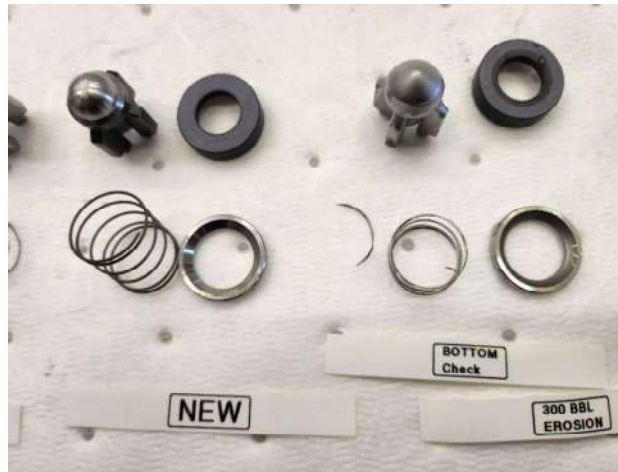
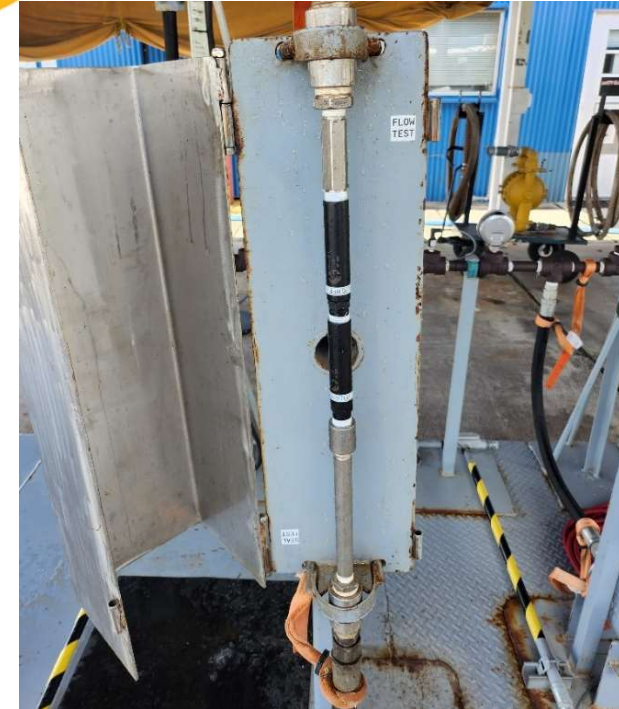
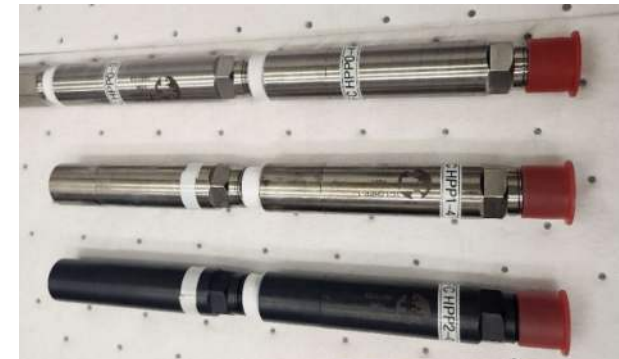
- Higher injection pressure at same rate appears to have destroyed check springs more quickly
- Dual checks failed seal testing 200 bbl **earlier** (sticking) than a single check
- Broken upper spring parts could interfere with lower check
- Dual checks are not better than single for erosion resistance
- However, dual checks may still offer sealing redundancy if **fluids are clean**

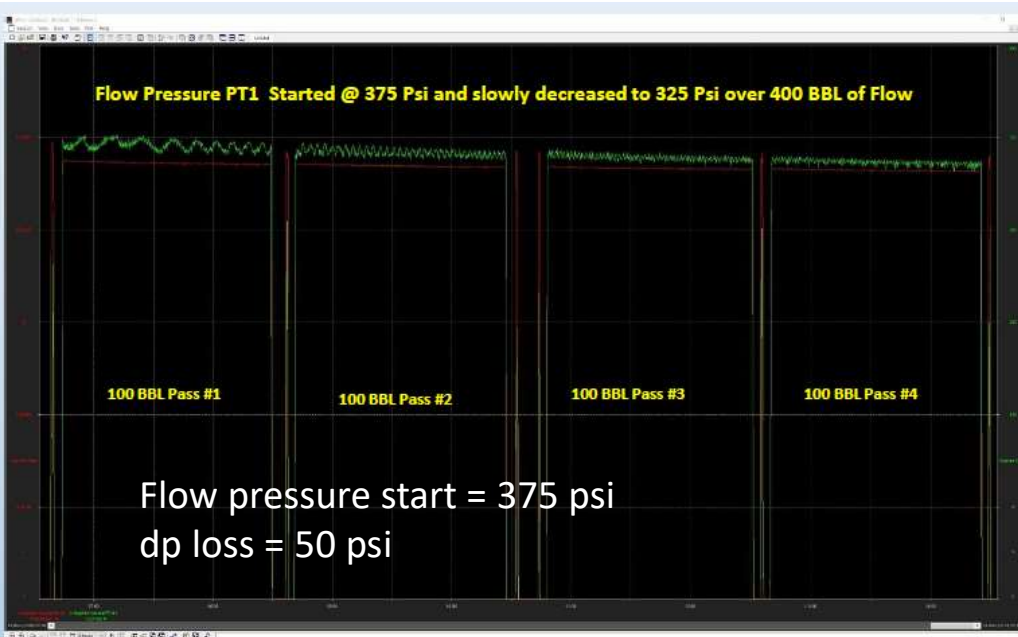
1" Model D.A.0

0.32" ID = **167.5 ft/s**

Smaller flow path = **2.5x** higher velocity = More severe erosion!

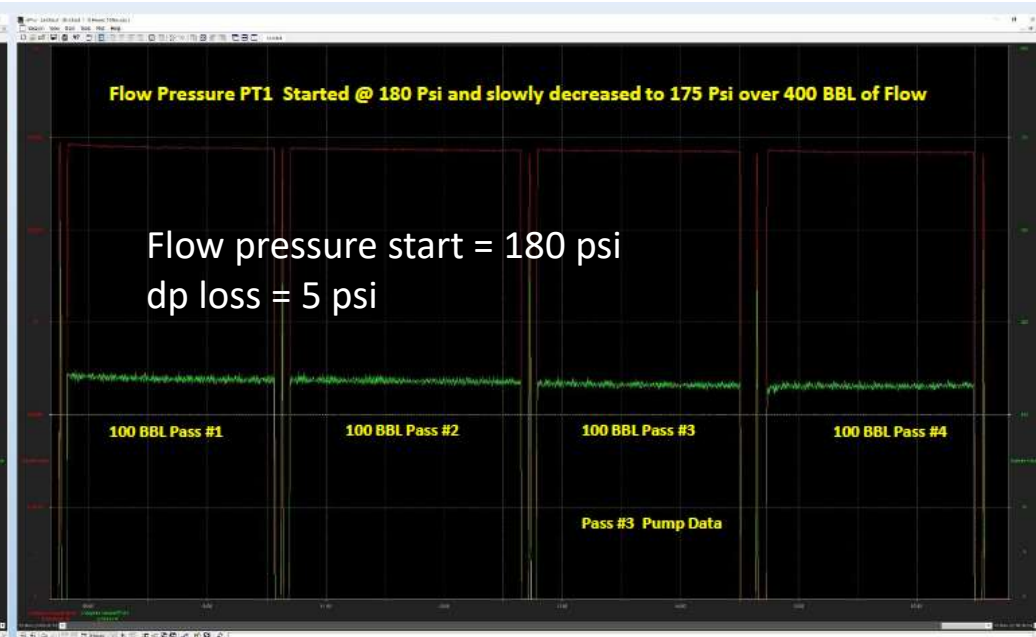
1.5" Model D.A.0

1.5" GLVs in EM Bakken
7" csg. have had minimal
solids-related issues

0.50" ID = **68.6 ft/s**

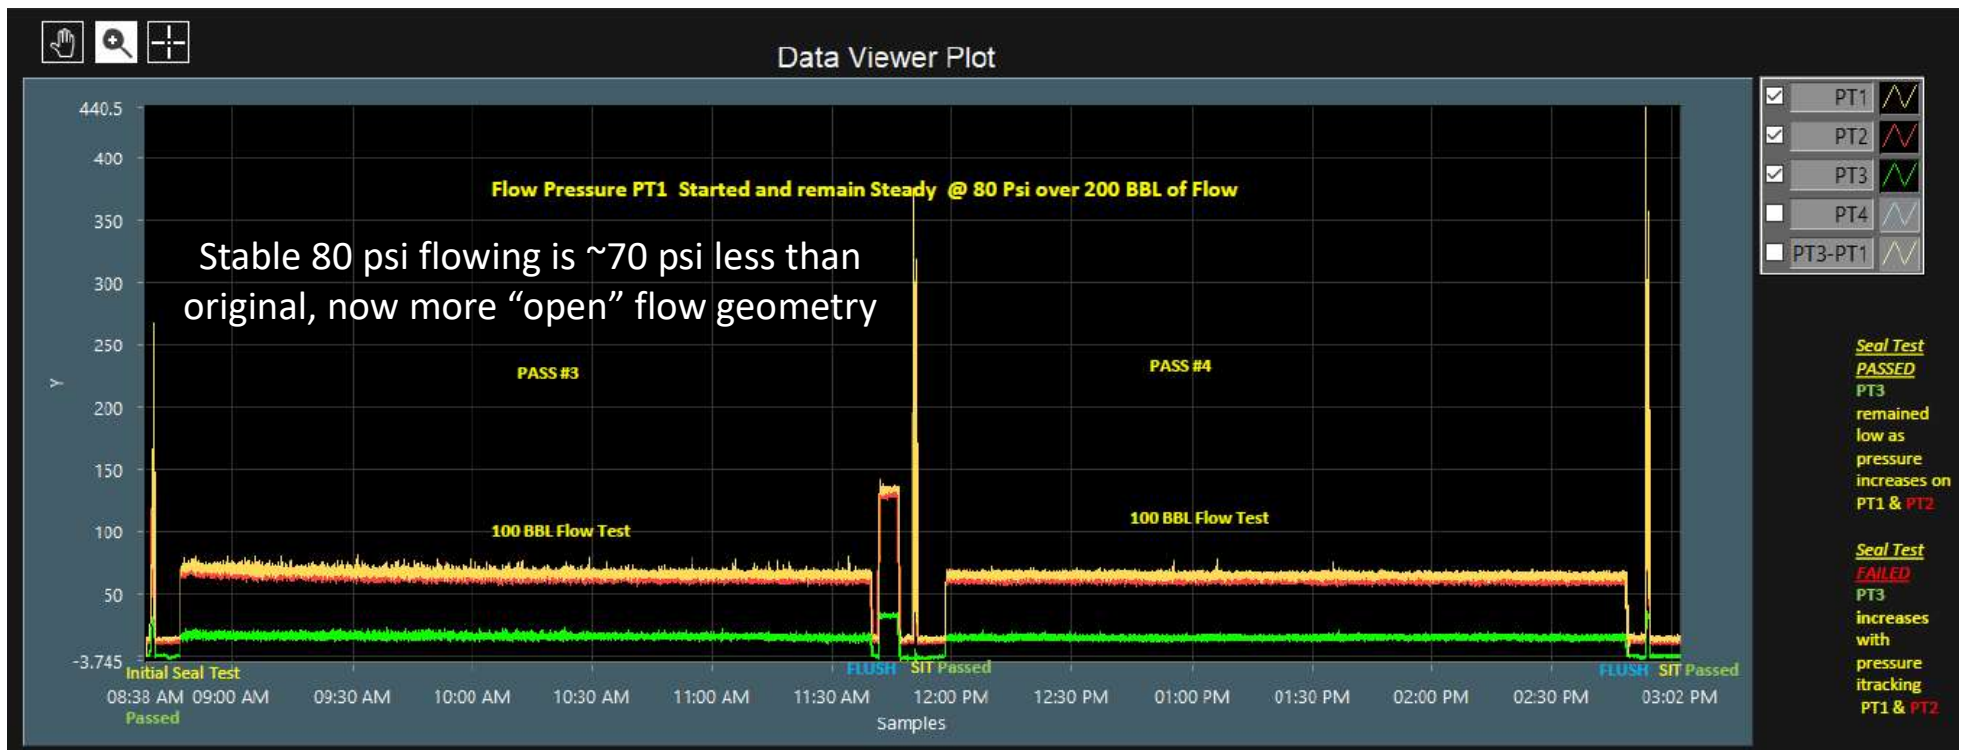
Model B.D

Sand Erosion Results – 1" Passing at 0.6 bbl/min

No need to punch the dart free between passes!

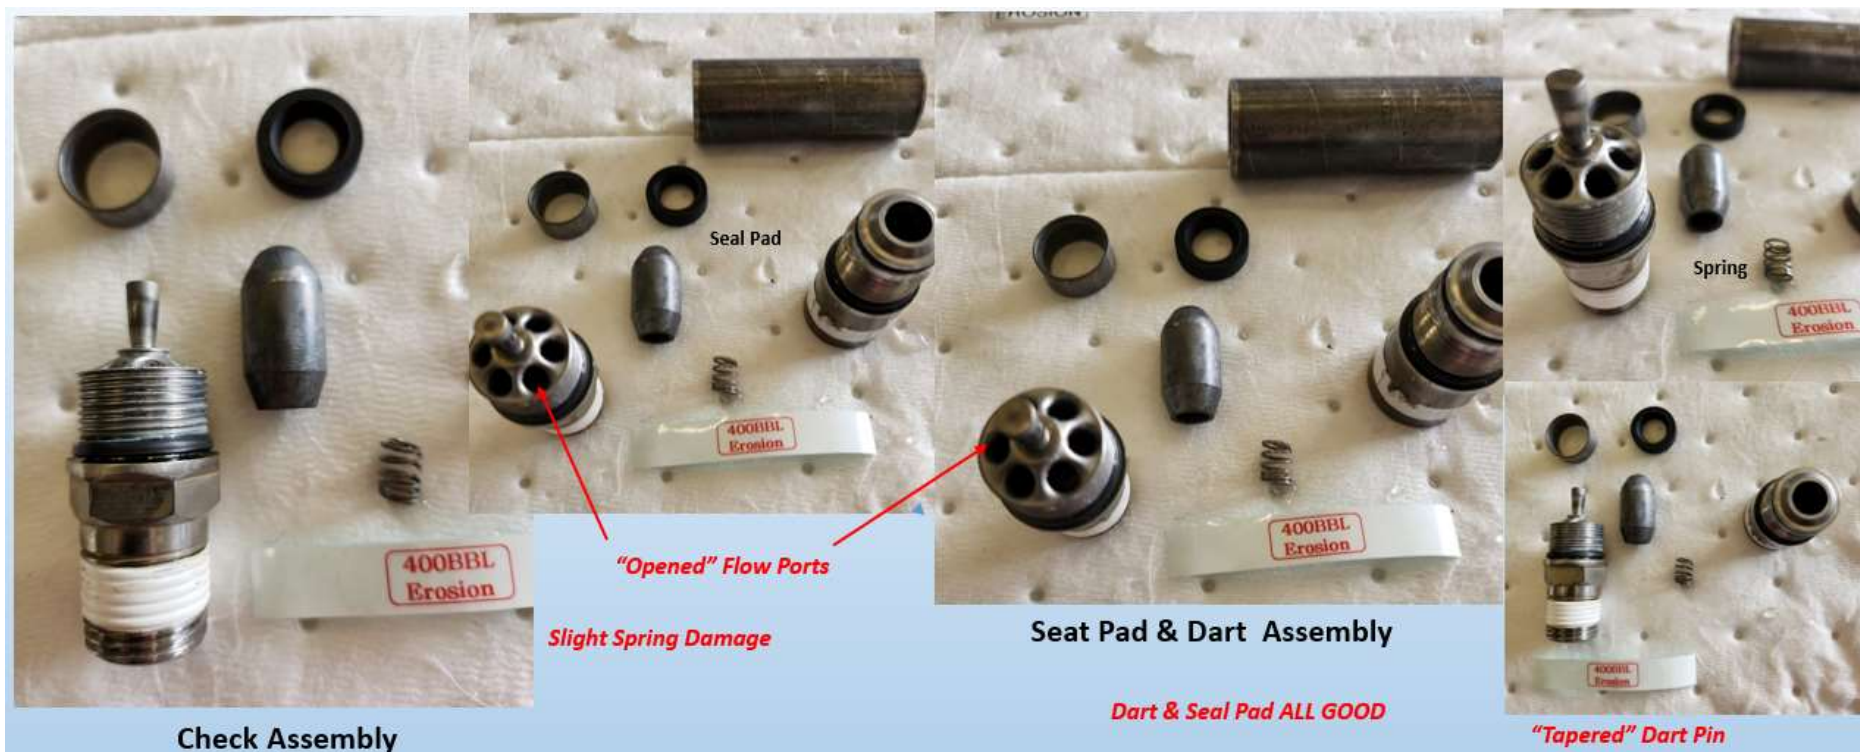
Sand Erosion Results – 1" Passing at 0.6 bbl/min

Worn, but functional. Improved materials, shielded spring

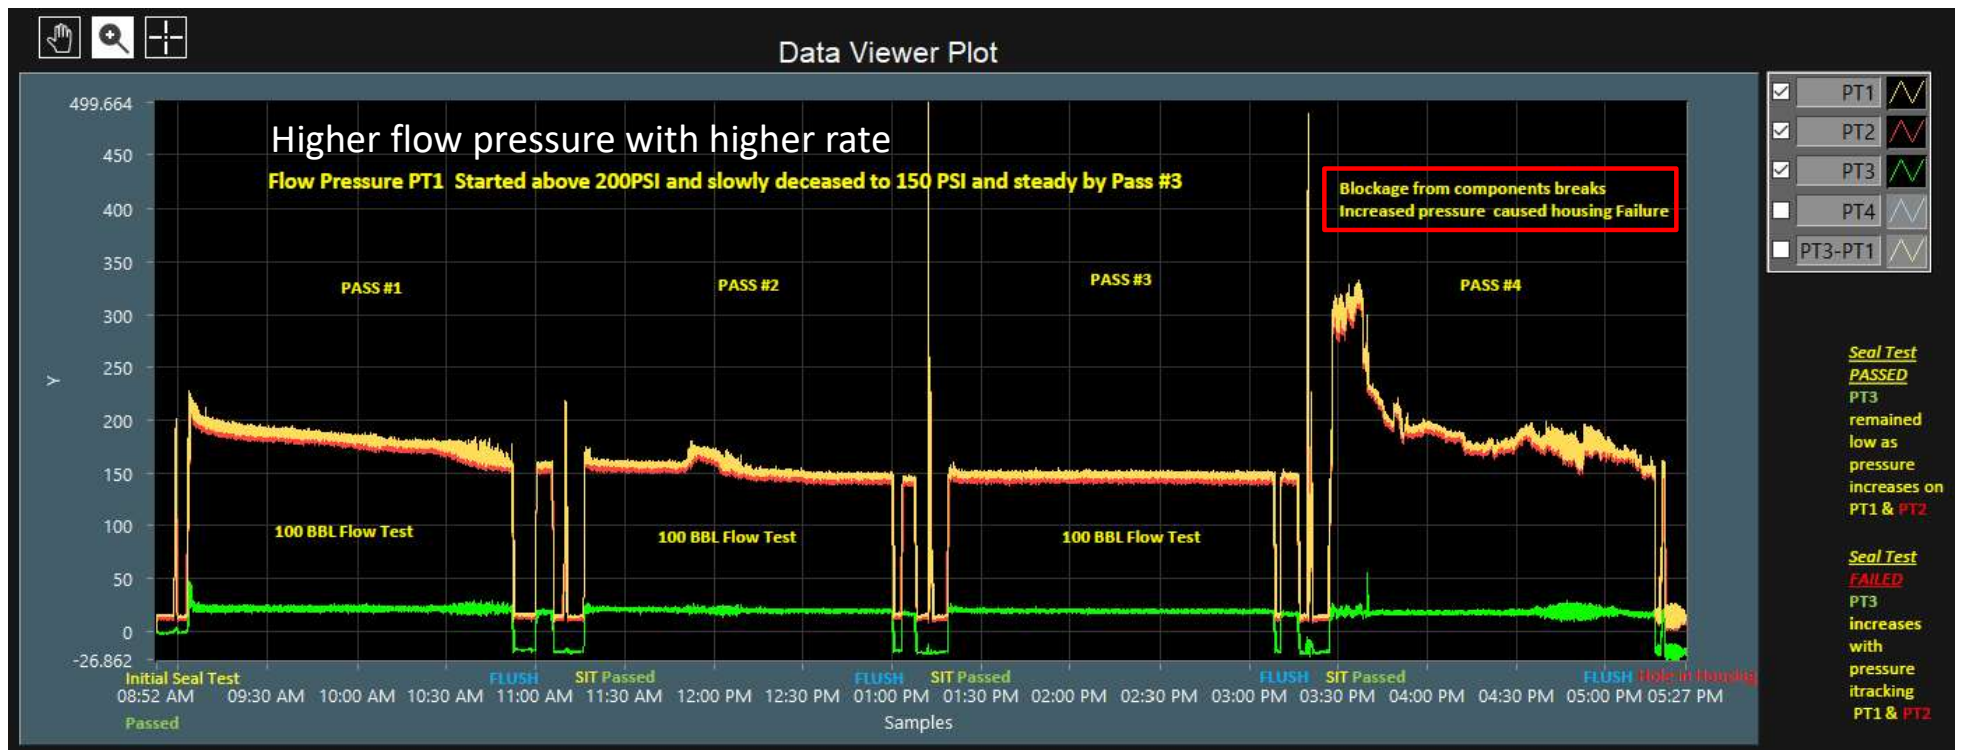
Model B.D

Sand Erosion Results – 1" Almost at 1.0 bbl/min

Component debris led to housing failure following 300 bbl check

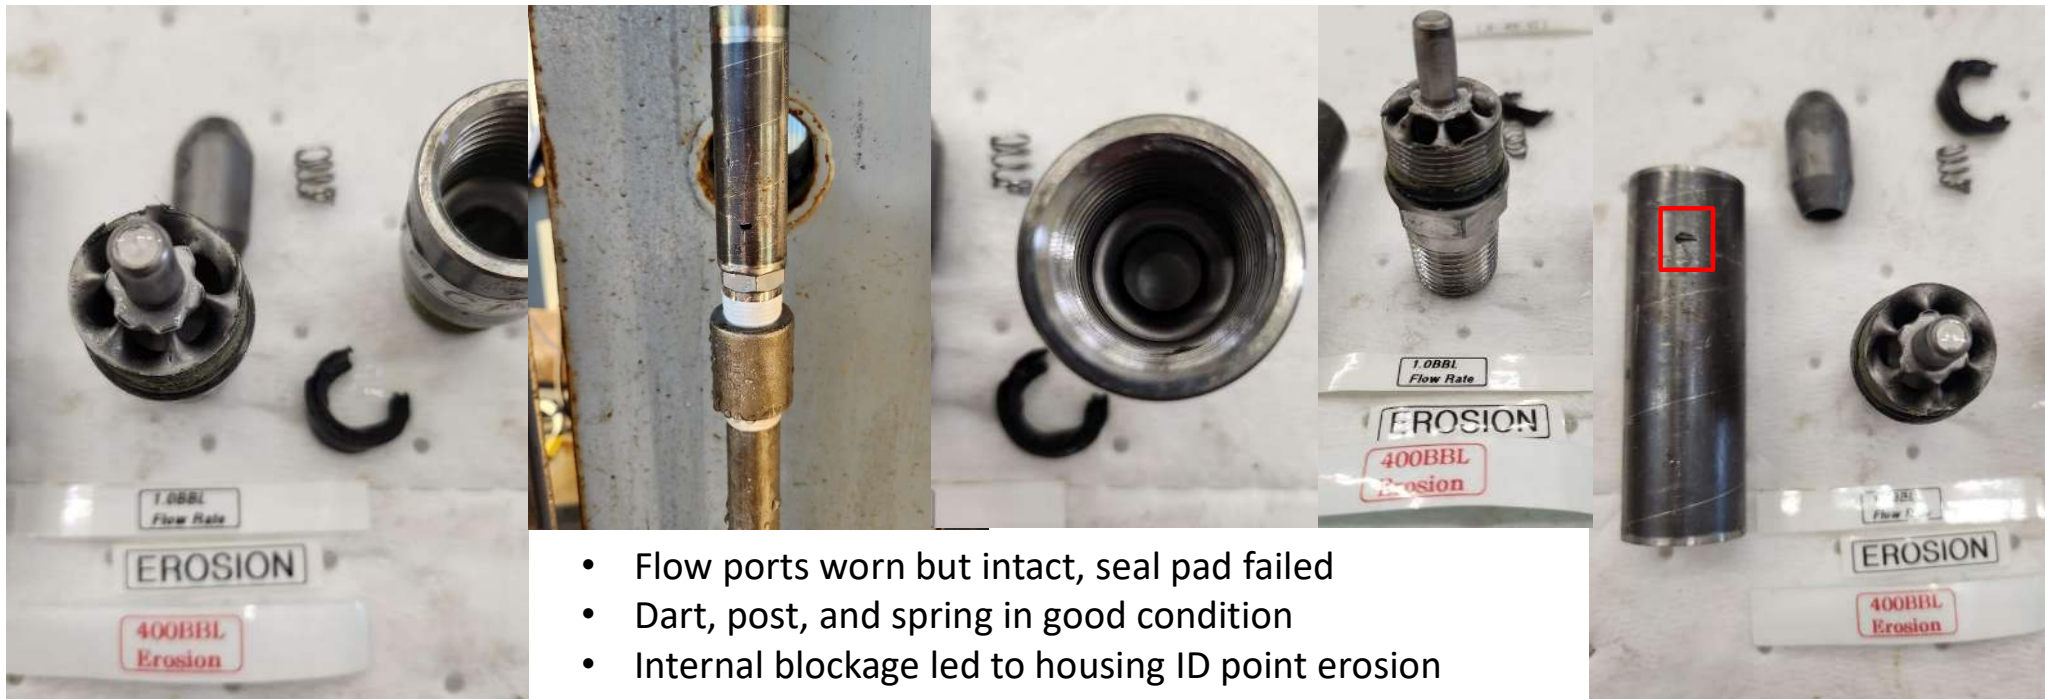
Sand Erosion Results – 1" Almost at 1.0 bbl/min

- Flow ports worn but intact, seal pad failed
- Dart, post, and spring in good condition
- Internal blockage led to housing ID point erosion
- Almost survived...
