2024 GAS LIFT WORKSHOP

Erosion Testing of Gas Lift Check Valves for Unconventional Applications

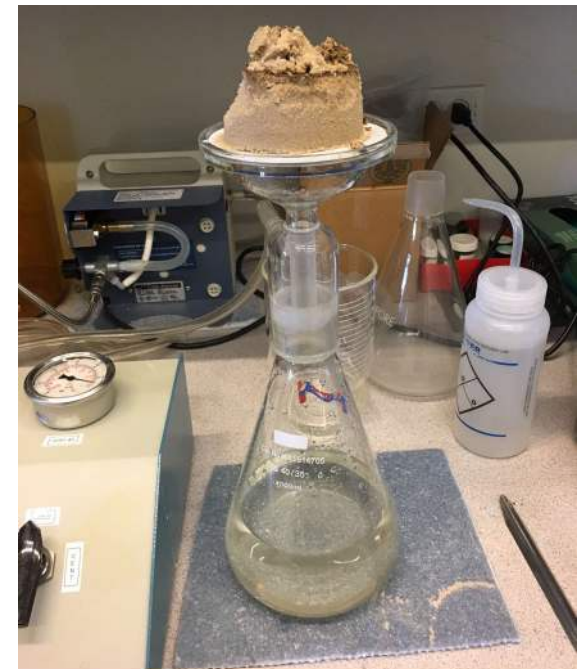
1% wt sand content
in 5 gal of mixture
